INVESTIGATIVE REPORT

STONES SQUARE CAR PARK AND OVERSPILL CAR PARKING BURLINGTON PLACE SHREWSBURY

SOUTH HERMITAGE MANAGEMENT COMPANY

**WEDNESDAY 7TH NOVEMBER
2012**

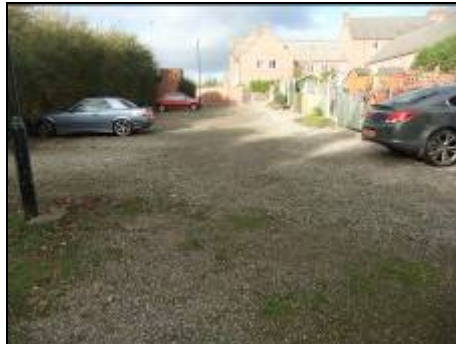
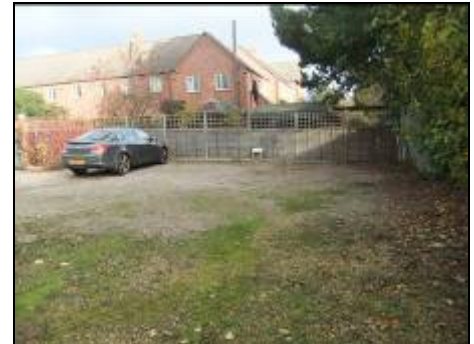
The word 'overspill' is not perhaps the best way of describing this car parking as it is a permanent arrangement. Nonetheless the current construction of the car park incorporates a surface made up of clean stone hardcore and does not incorporate any formal edgings in the form of pre-cast concrete kerbs or any drainage arrangements other than percolation. A couple of photographs of the current arrangement are shown below which clearly detail the gravel type finish to the car park and the distinct lack of routine maintenance resulting in vegetation growth particularly at the one end.

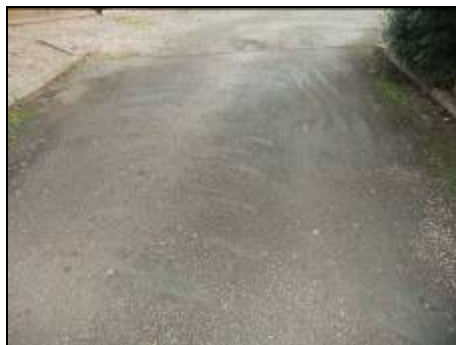
It was also observed at the junction with the access road, that the tarmacadam surfacing to the access road is beginning to spall due to vehicular movement and a pot hole has appeared within the gravelled car park. We would recommend that the access road is maintained where all vegetation growth should be removed to the kerb lines and this should be undertaken at least on an annual basis. Obviously the pot hole requires repairing immediately but we are of the opinion that resurfacing in the form of an additional wearing course on the access road is not required at this stage. This is illustrated on the photograph below.

Thoroughly clean the access road, repair the pot hole, repair the boundaries and ideally remove the overgrowth to the surface of the car park at the lower end.

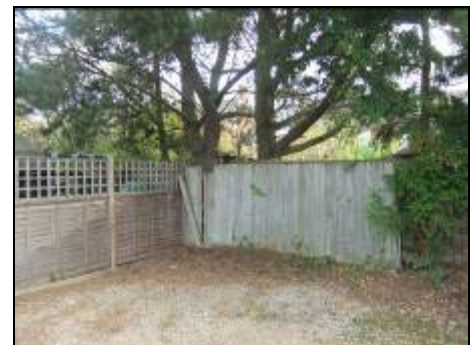
The right hand photograph above also shows the poor condition of the boundary fence to the lower section of the car park where immediate repairs are required. South Heritage Management Company should make enquiries with the appropriate deeds as to who is responsible for repair and maintenance of the boundaries.
